Safe use of bed rails

Bed rails successfully prevent many falls, but their incorrect use has resulted in the deaths of bed occupants by asphyxiation through entrapment in gaps.

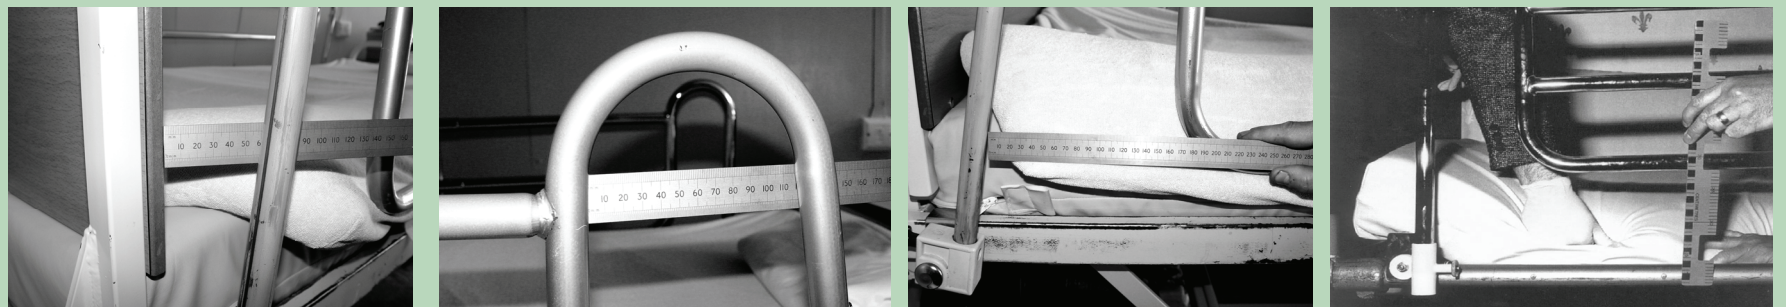
'Third party' bed rails, as photographed below, are not model specific and fit a wide range of beds. The principles set out below apply to all types of bed rails.

Bed rails should be fitted so that the gap between their end and the headboard is less than 60mm.

All gaps between the rail bars for adults must be 120mm or less and for children 60mm or less.

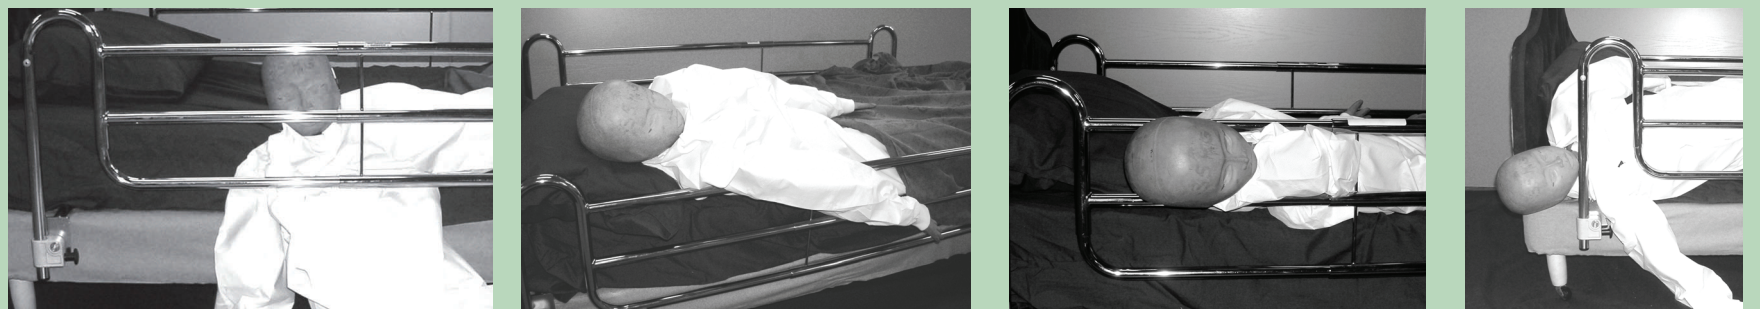
Most of the deaths caused by bed rails could have been avoided if thorough risk assessments of the bed occupant, the bed and the bed rail combination had been carried out.

MHRA investigations have also shown that many serious and fatal incidents with bed rails have been caused by a lack of maintenance.

Bed rails must be inspected on a regular basis to ensure they are in good condition.
